History and Status of the Chicago Aquatic Nuisance Species Dispersal Barrier

Phil Moy

University of Wisconsin

Dispersal Barrier Project

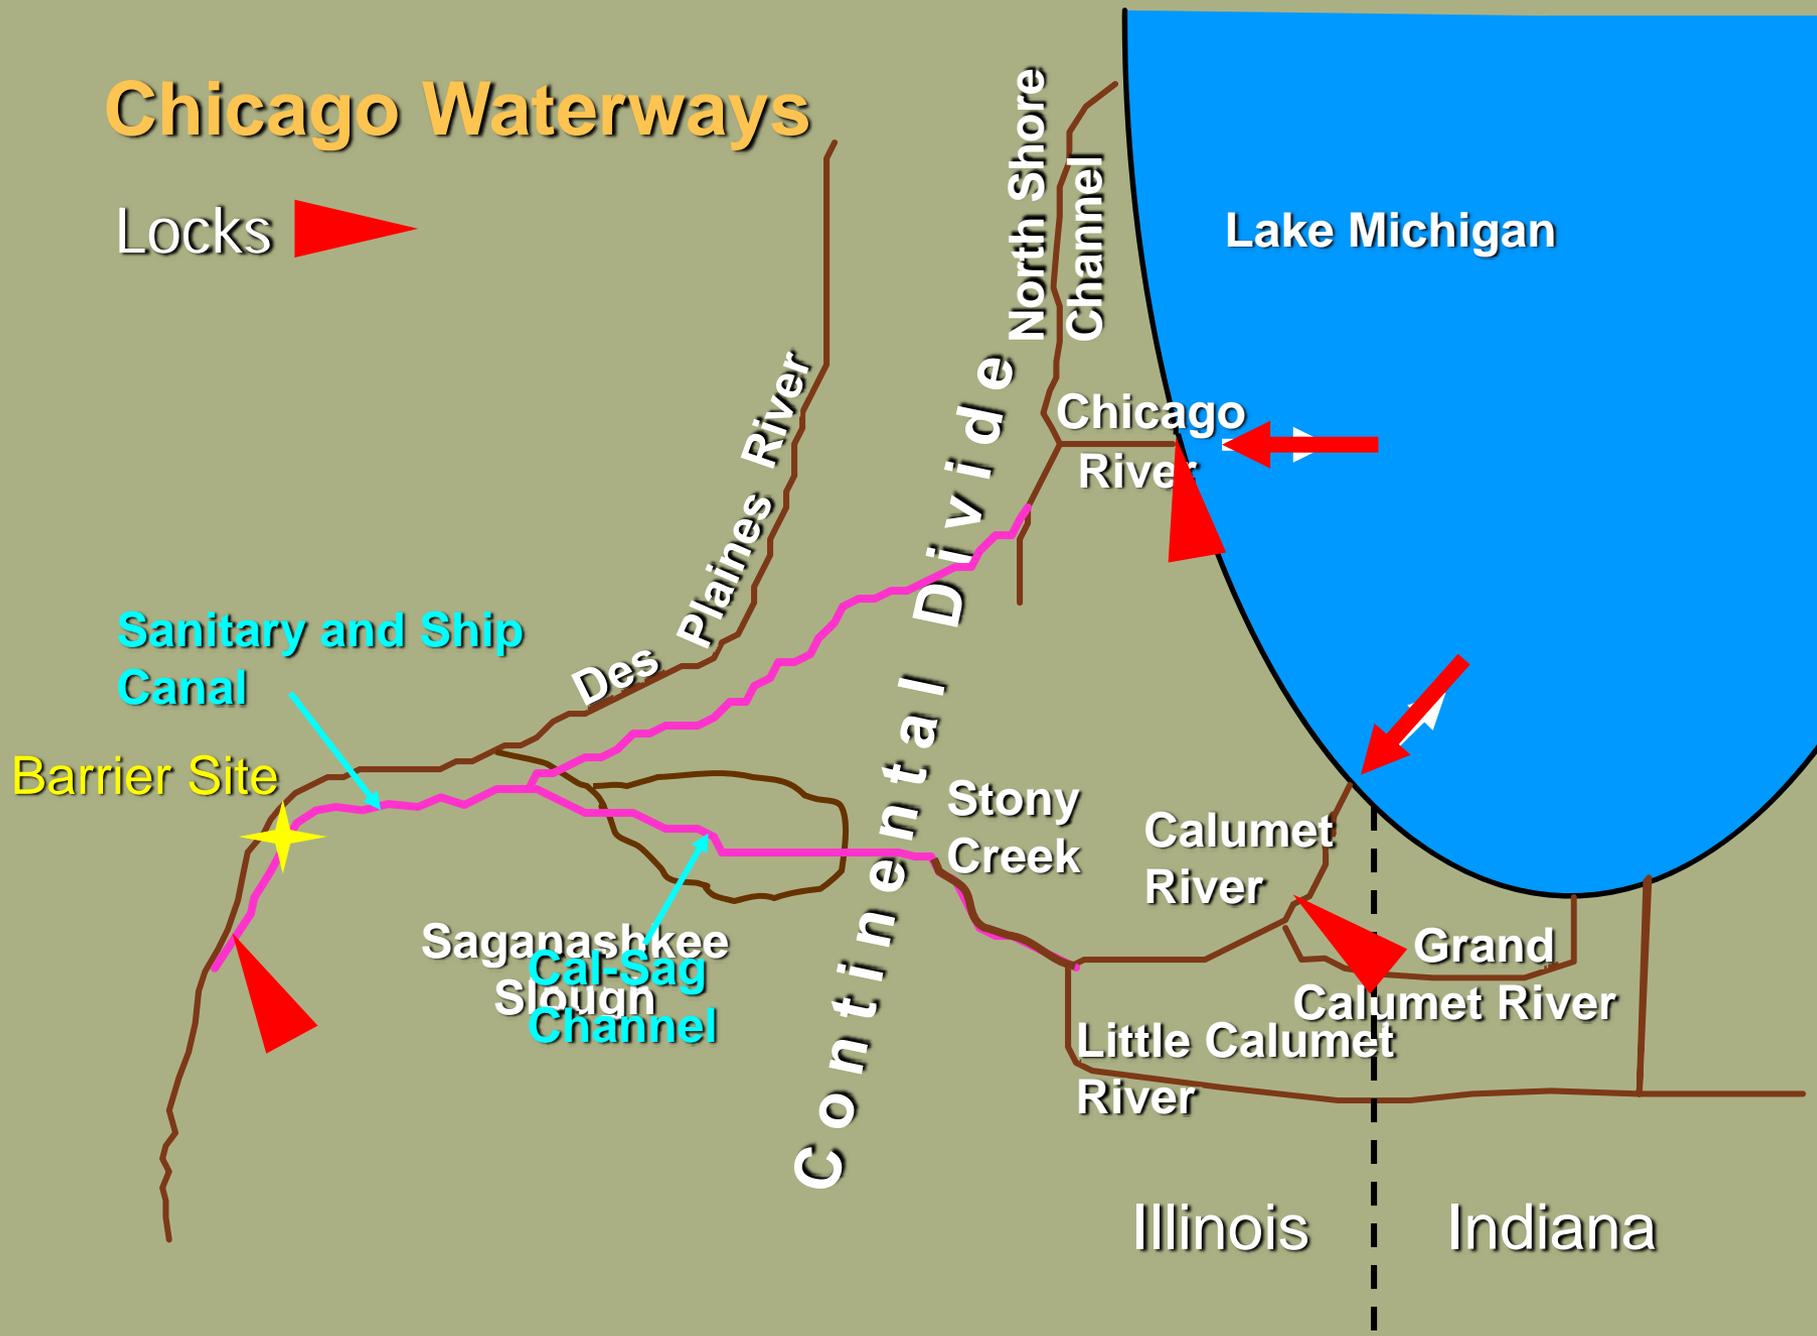
Chicago Sanitary and Ship Canal near Romeoville, IL

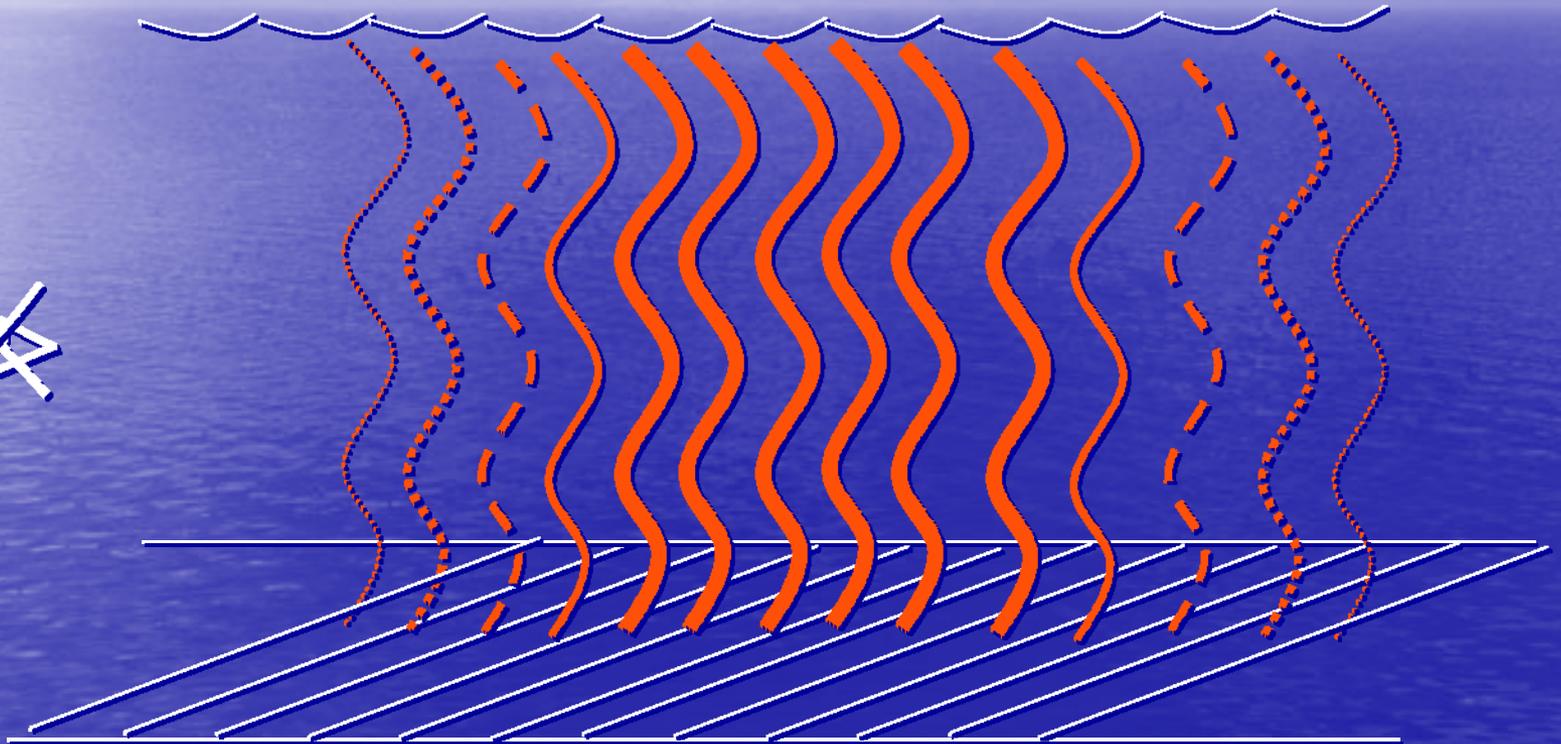
Barrier Effect

- Micro-Pulsed DC; Graded field
- Few permitting issues
- Available technology - used in irrigation canals and for lamprey control
- High chance of success
- Electrodes on the bottom and recessed in the walls to avoid damage by barges

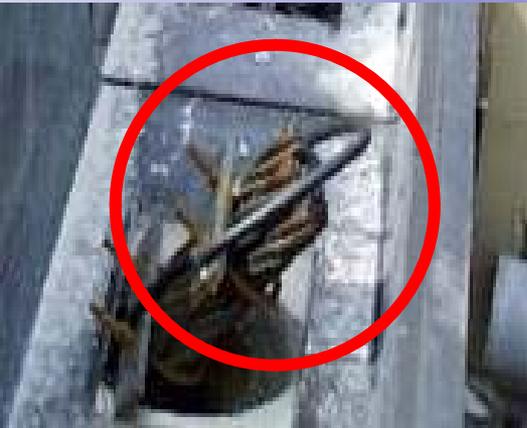
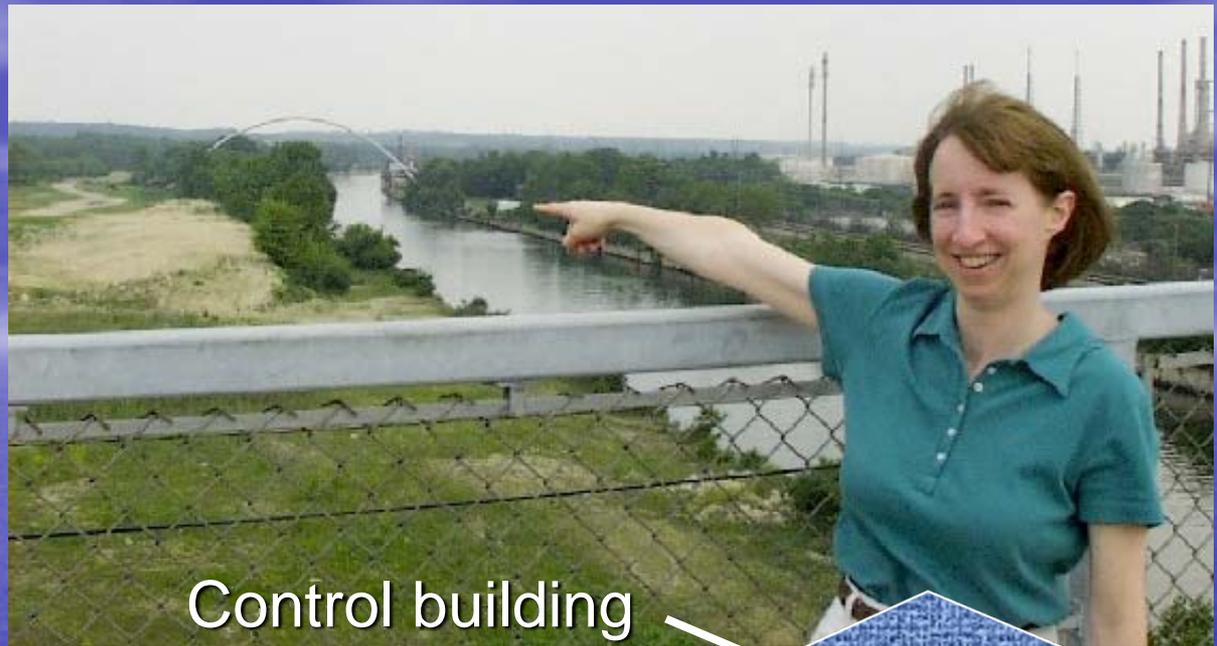
Barrier I

Control building

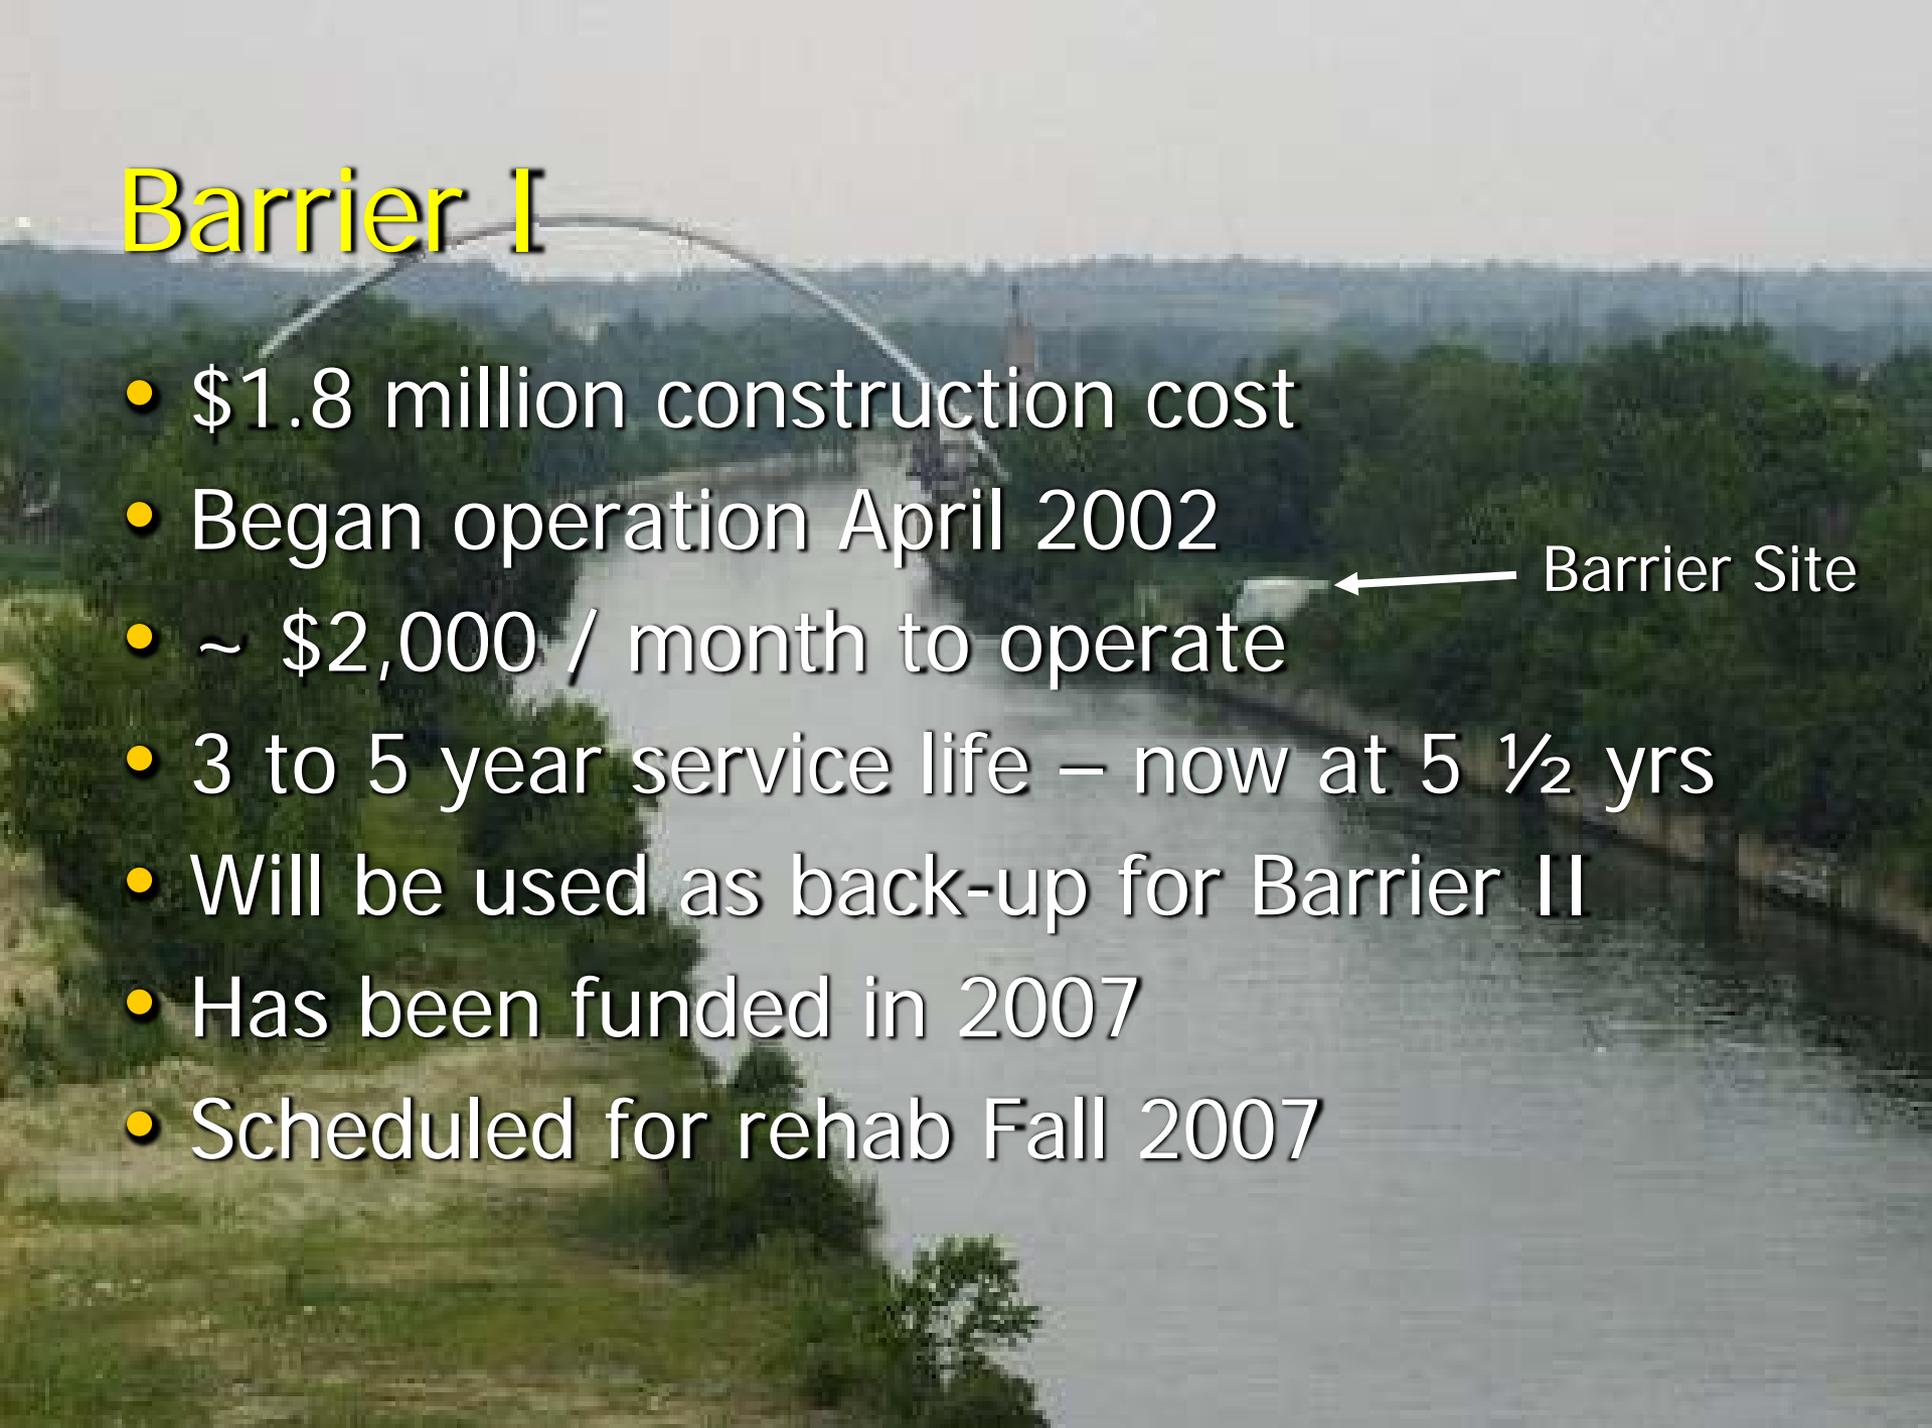
Barrier I

- \$1.8 million construction cost
 - Began operation April 2002
 - ~ \$2,000 / month to operate
 - 3 to 5 year service life – now at 5 ½ yrs
 - Will be used as back-up for Barrier II
 - Has been funded in 2007
 - Scheduled for rehab Fall 2007
- Barrier Site

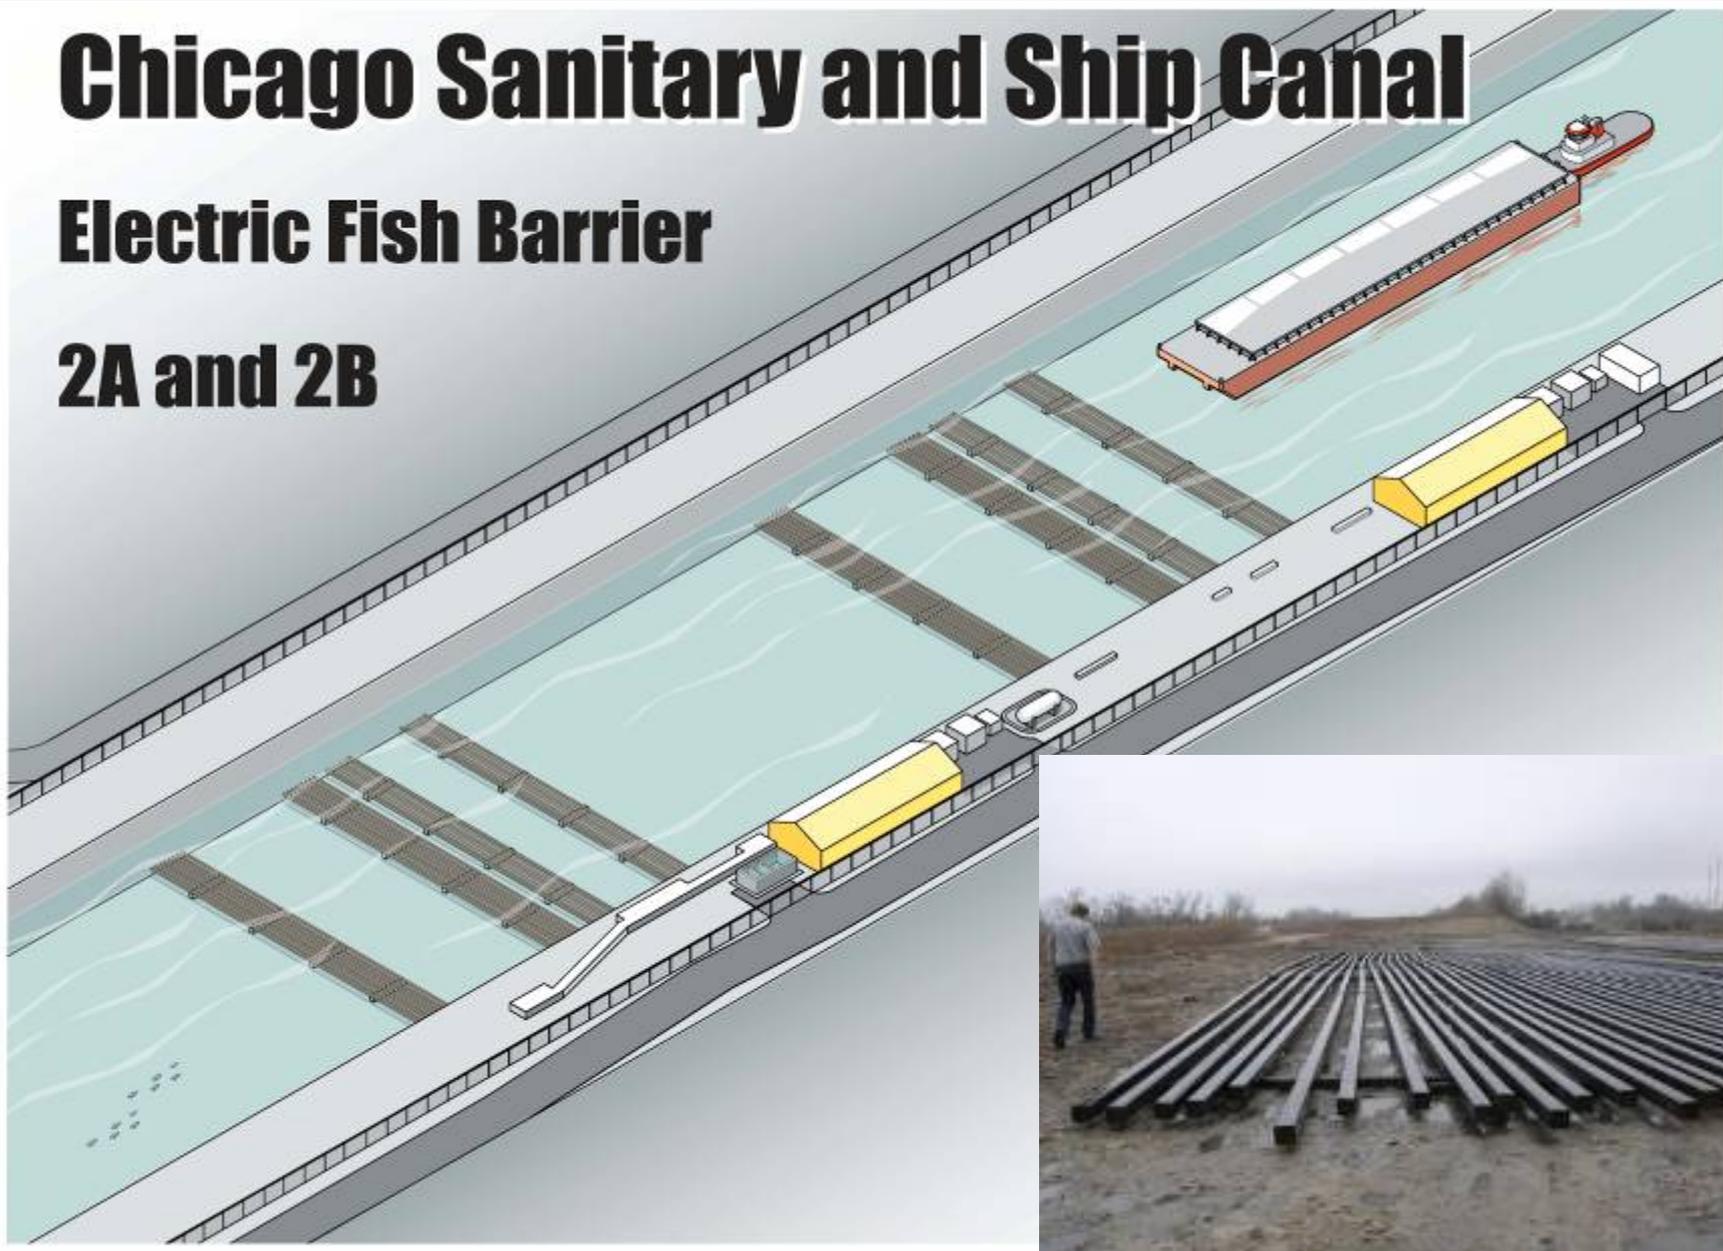
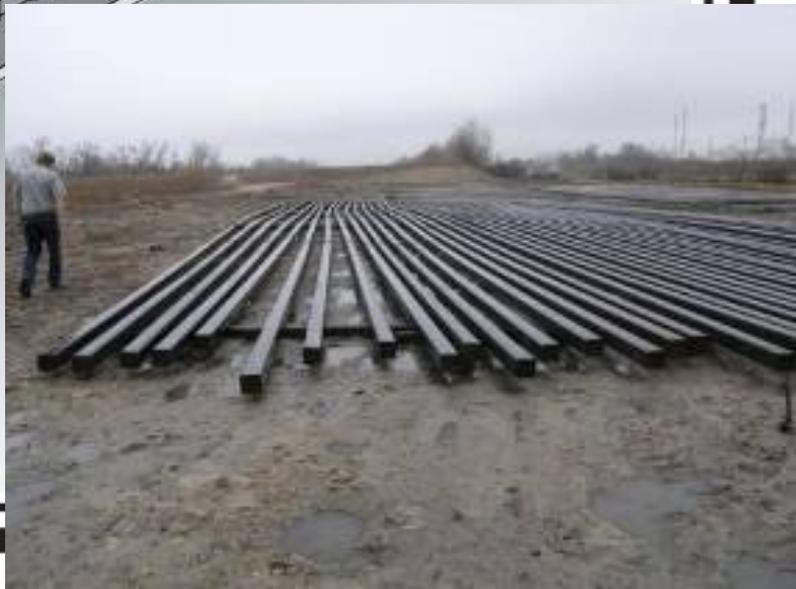
2A and 2B

Chicago Sanitary and Ship Canal

Electric Fish Barrier

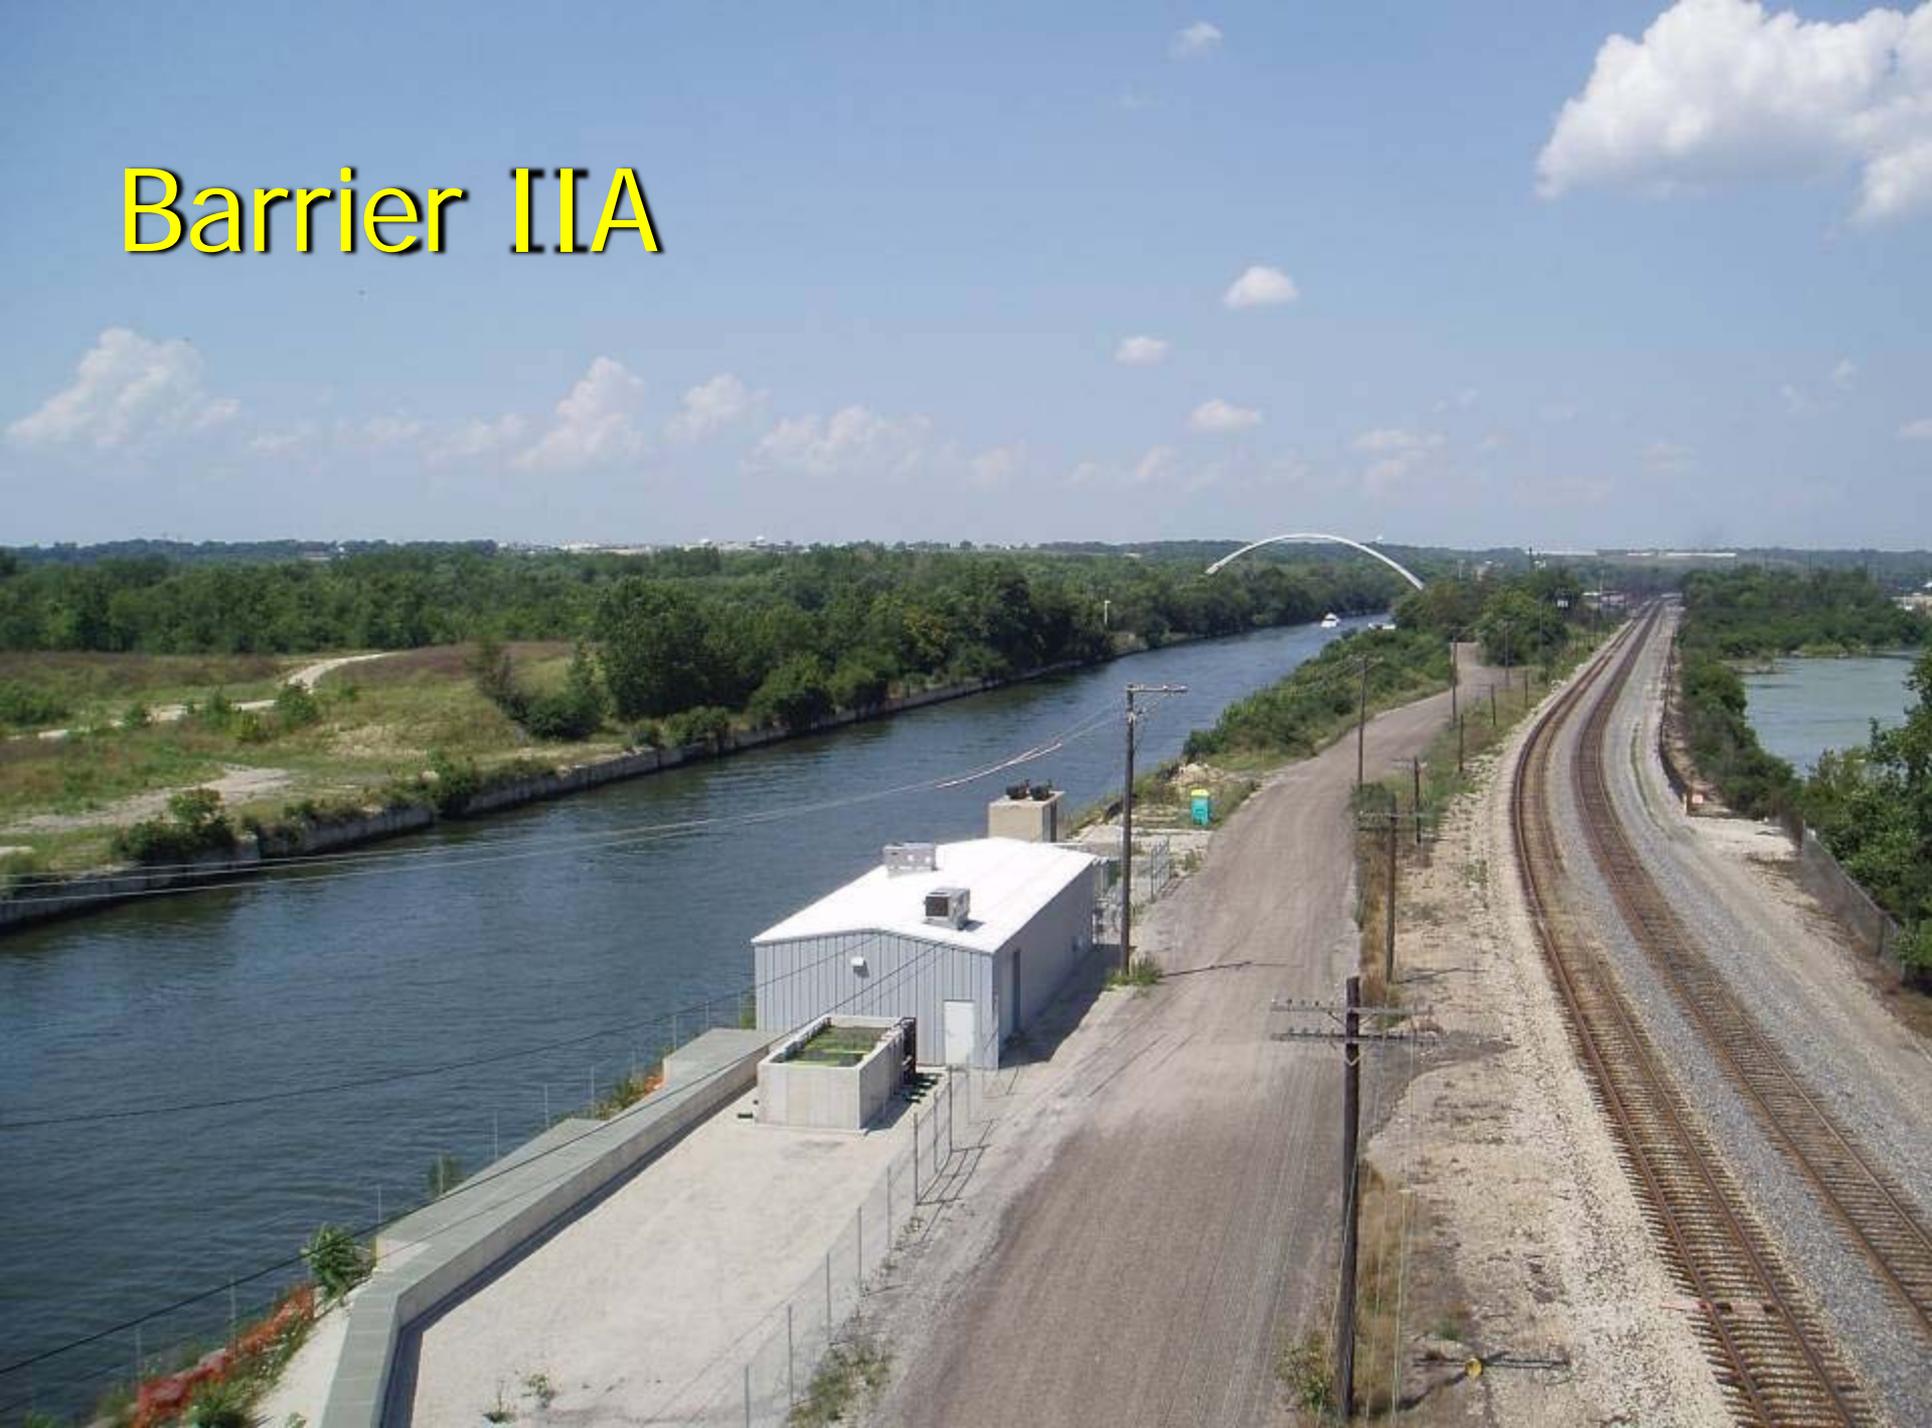
Barrier IIA

Barrier II

- Two arrays
- 350 feet long (10X Barrier I)
- 6x6" Steel electrodes = 20-year service life
- Cost \$9.1 million; 75% Federal
- IL DNR provided \$1.8 million
- Other 7 Great Lakes States ~ \$70,000 each
- Need \$8.5 million more to complete

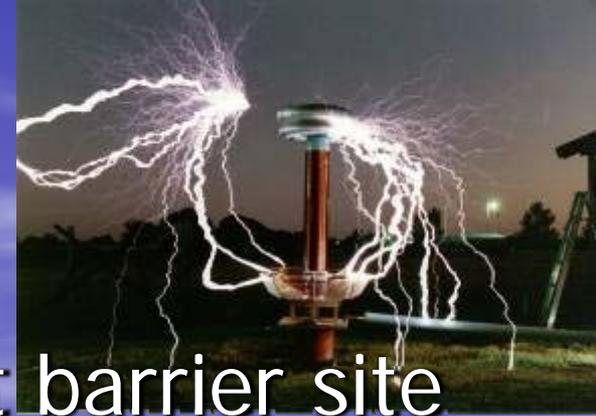
- Barge crew observed arcing at barrier site
- Arcing assess study completed March 2005
- Confirmed arcing could occur between barges
- USCG established a restricted activity zone:
 - No passing, mooring, single barge-wide tows
 - Special safety requirements – steel cables
 - All vessel occupants to wear PFDs

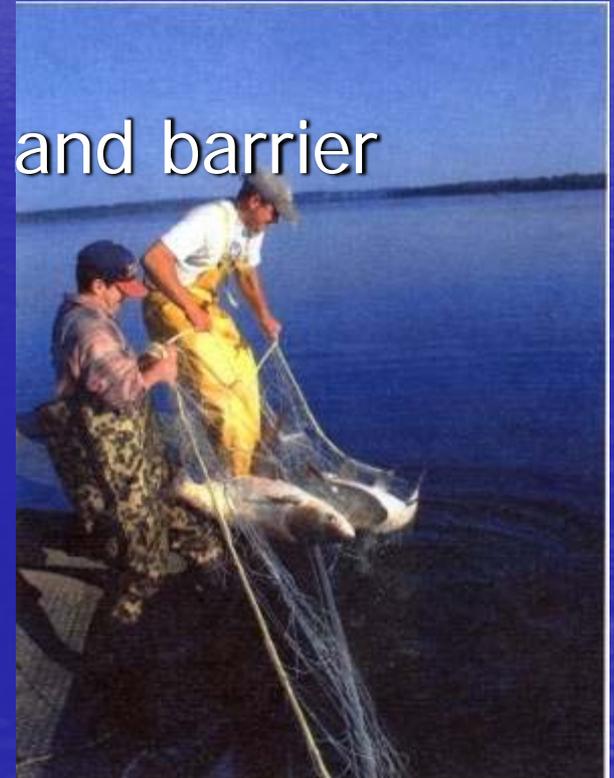
Asian Carp captures ★

- June 2007, 13 Asian carp captured 13-15 miles below barrier in Des Plaines River
- 50+ miles from Lake Michigan
- Two locks between capture site and barrier

Barrier Site: 296.5 ★

Lockport Lock ◆

Brandon Road Lock ◆

RM 284
2007

RM 274
2002

12.5 Mi

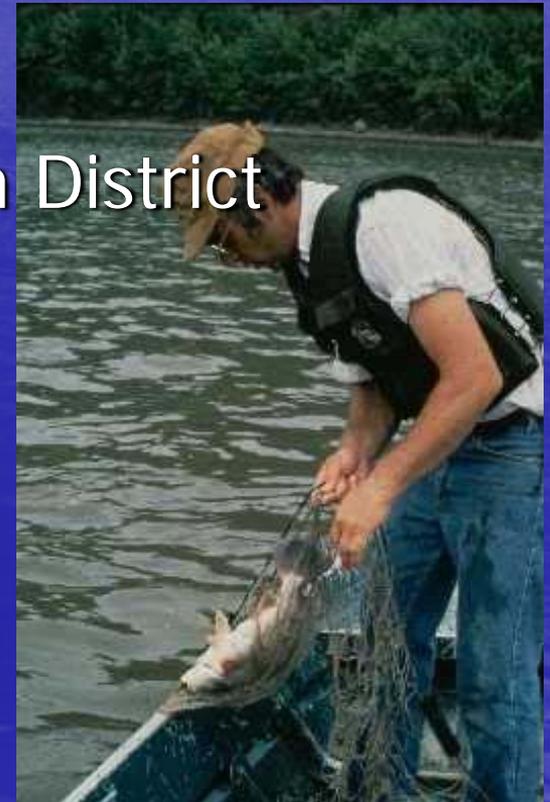
Asian Carp Monitoring Area

Locks

Barrier Site

4 sites

Monthly samples

Fyke, trammel nets

Electrofishing
